TEST REPORT NO. 53628-2

TEST, ENGINEERING AND RESEARCH GROUP, SAN BERNARDINO

Pelican Products, Inc.  
23215 Early Avenue  
Torrance, CA 90505

One Case, Part No. 1430-001-110 (no serial number) was subjected to Dust IP6X Category 2 Testing and Immersion IPX7 Testing in accordance with CEI IEC 529 specifications. Upon completion of the tests, no visible evidence of damage to the test specimen was observed. Complete test details, including photos and equipment lists, are contained in this report.

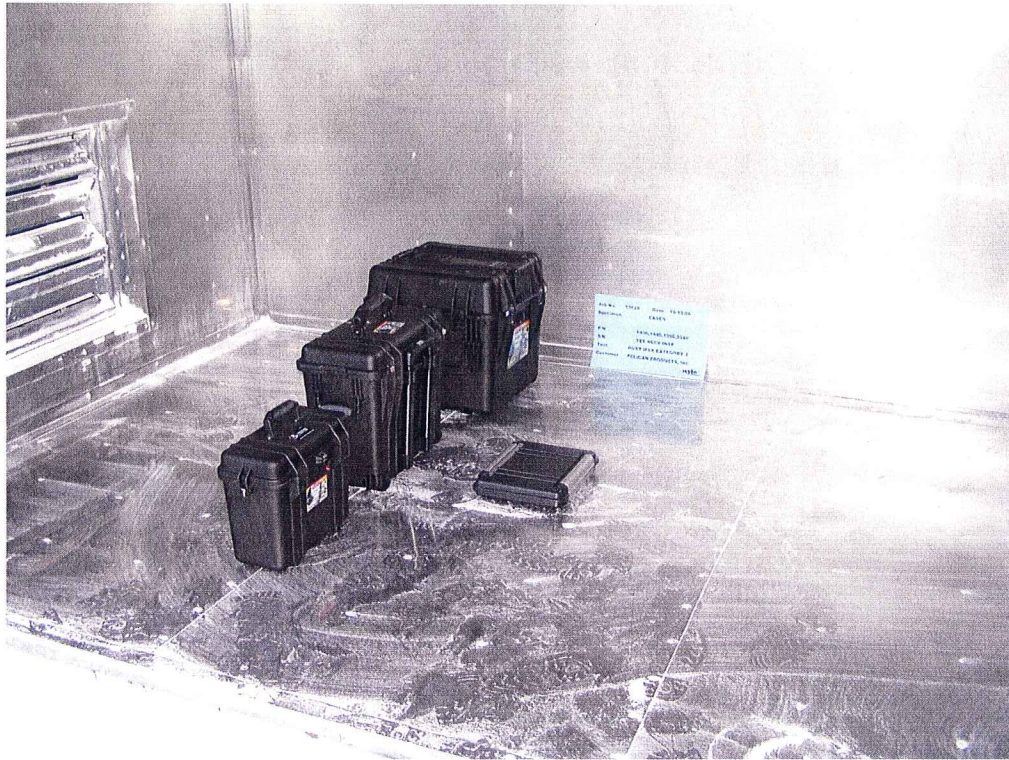
*Photograph 1  
Dust Test Setup (Tested with other Pelican Product Items)*

Place the test specimen in a test chamber. Establish a dust concentration of 2 Kg per cubic meter of test chamber volume. Expose the test specimen to this dust environment for 8 hours.

Remove accumulated dust from the test specimen by brushing, wiping, or shaking, taking care to avoid introducing additional dust into the test item. Do not remove dust by either air blast or vacuum cleaning. Perform a visual examination for evidence of damage or deterioration.

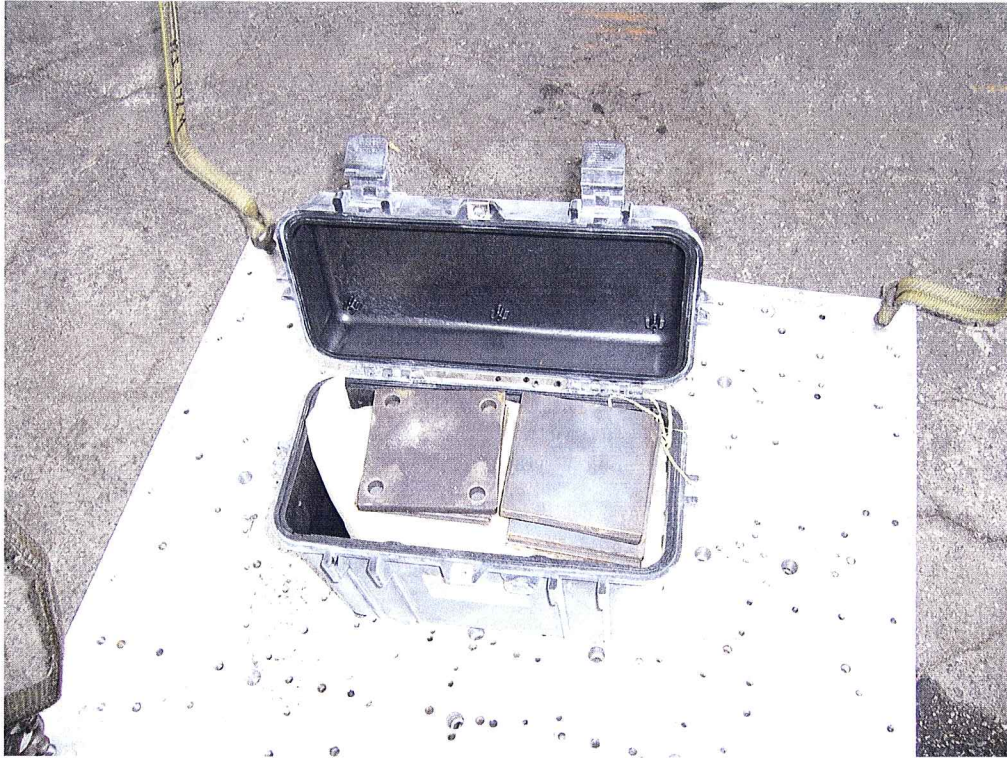
*Photograph 3  
Immersion Test Setup*

Visually inspect the test specimen. Place the test specimen in a submersion tank. Test specimens with a height less than 850 mm (33.46 inches) has the lowest point of the test specimen 1000 mm (39.37 inches) below the surface of the water surface. Test specimens with a height equal to or greater than 850 mm (33.46 inches) has the highest point of the test specimen 150 mm (3.9 inches) below the surface of the water.

The test was performed in accordance with the Test Method and Requirements stated above. Small weights and sand bags totaling 58 lbs were placed inside the test specimen to eliminate buoyancy. Upon completion of the test, no water was observed inside the test specimen. No visible evidence of damage to the test specimen was observed upon completion of testing.

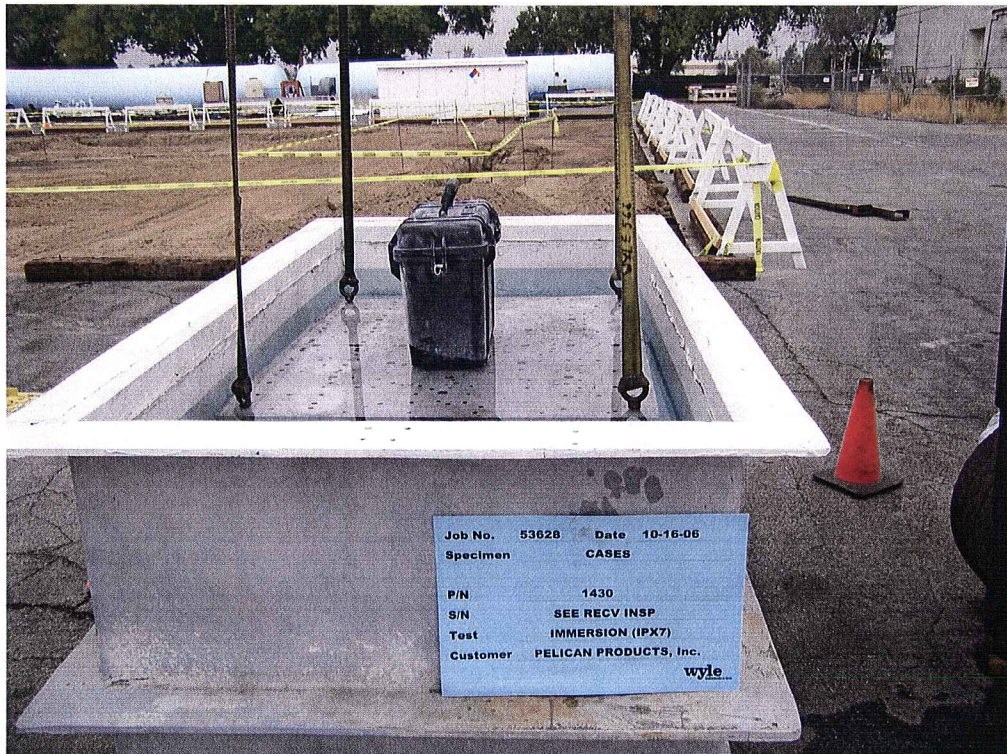
*Photograph 4  
Immersion Test Setup*

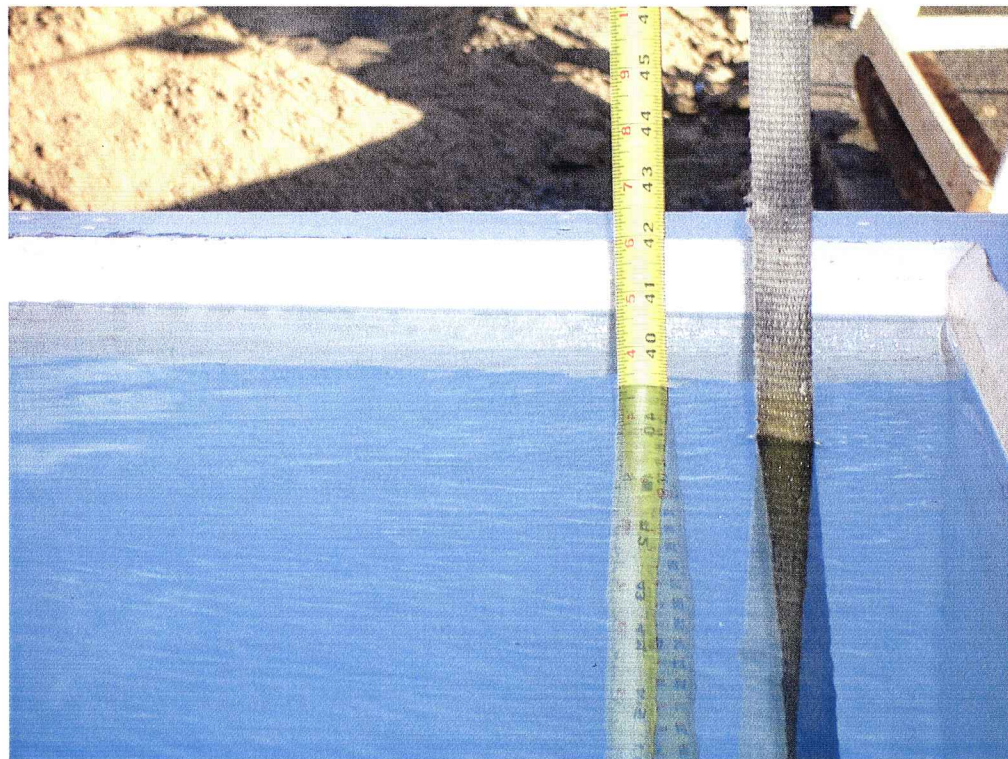
*Photograph 6  
Immersion Test Setup*
